TS-PIC-88710
May 1988

AERIAL PHOTOGRAPHIC ANALYSIS OF THE COMBE FILL SOUTH LANDFILL Chester, New Jersey

AERIAL PHOTOGRAPHIC ANALYSIS OF THE COMBE FILL SOUTH LANDFILL

Chester, New Jersey

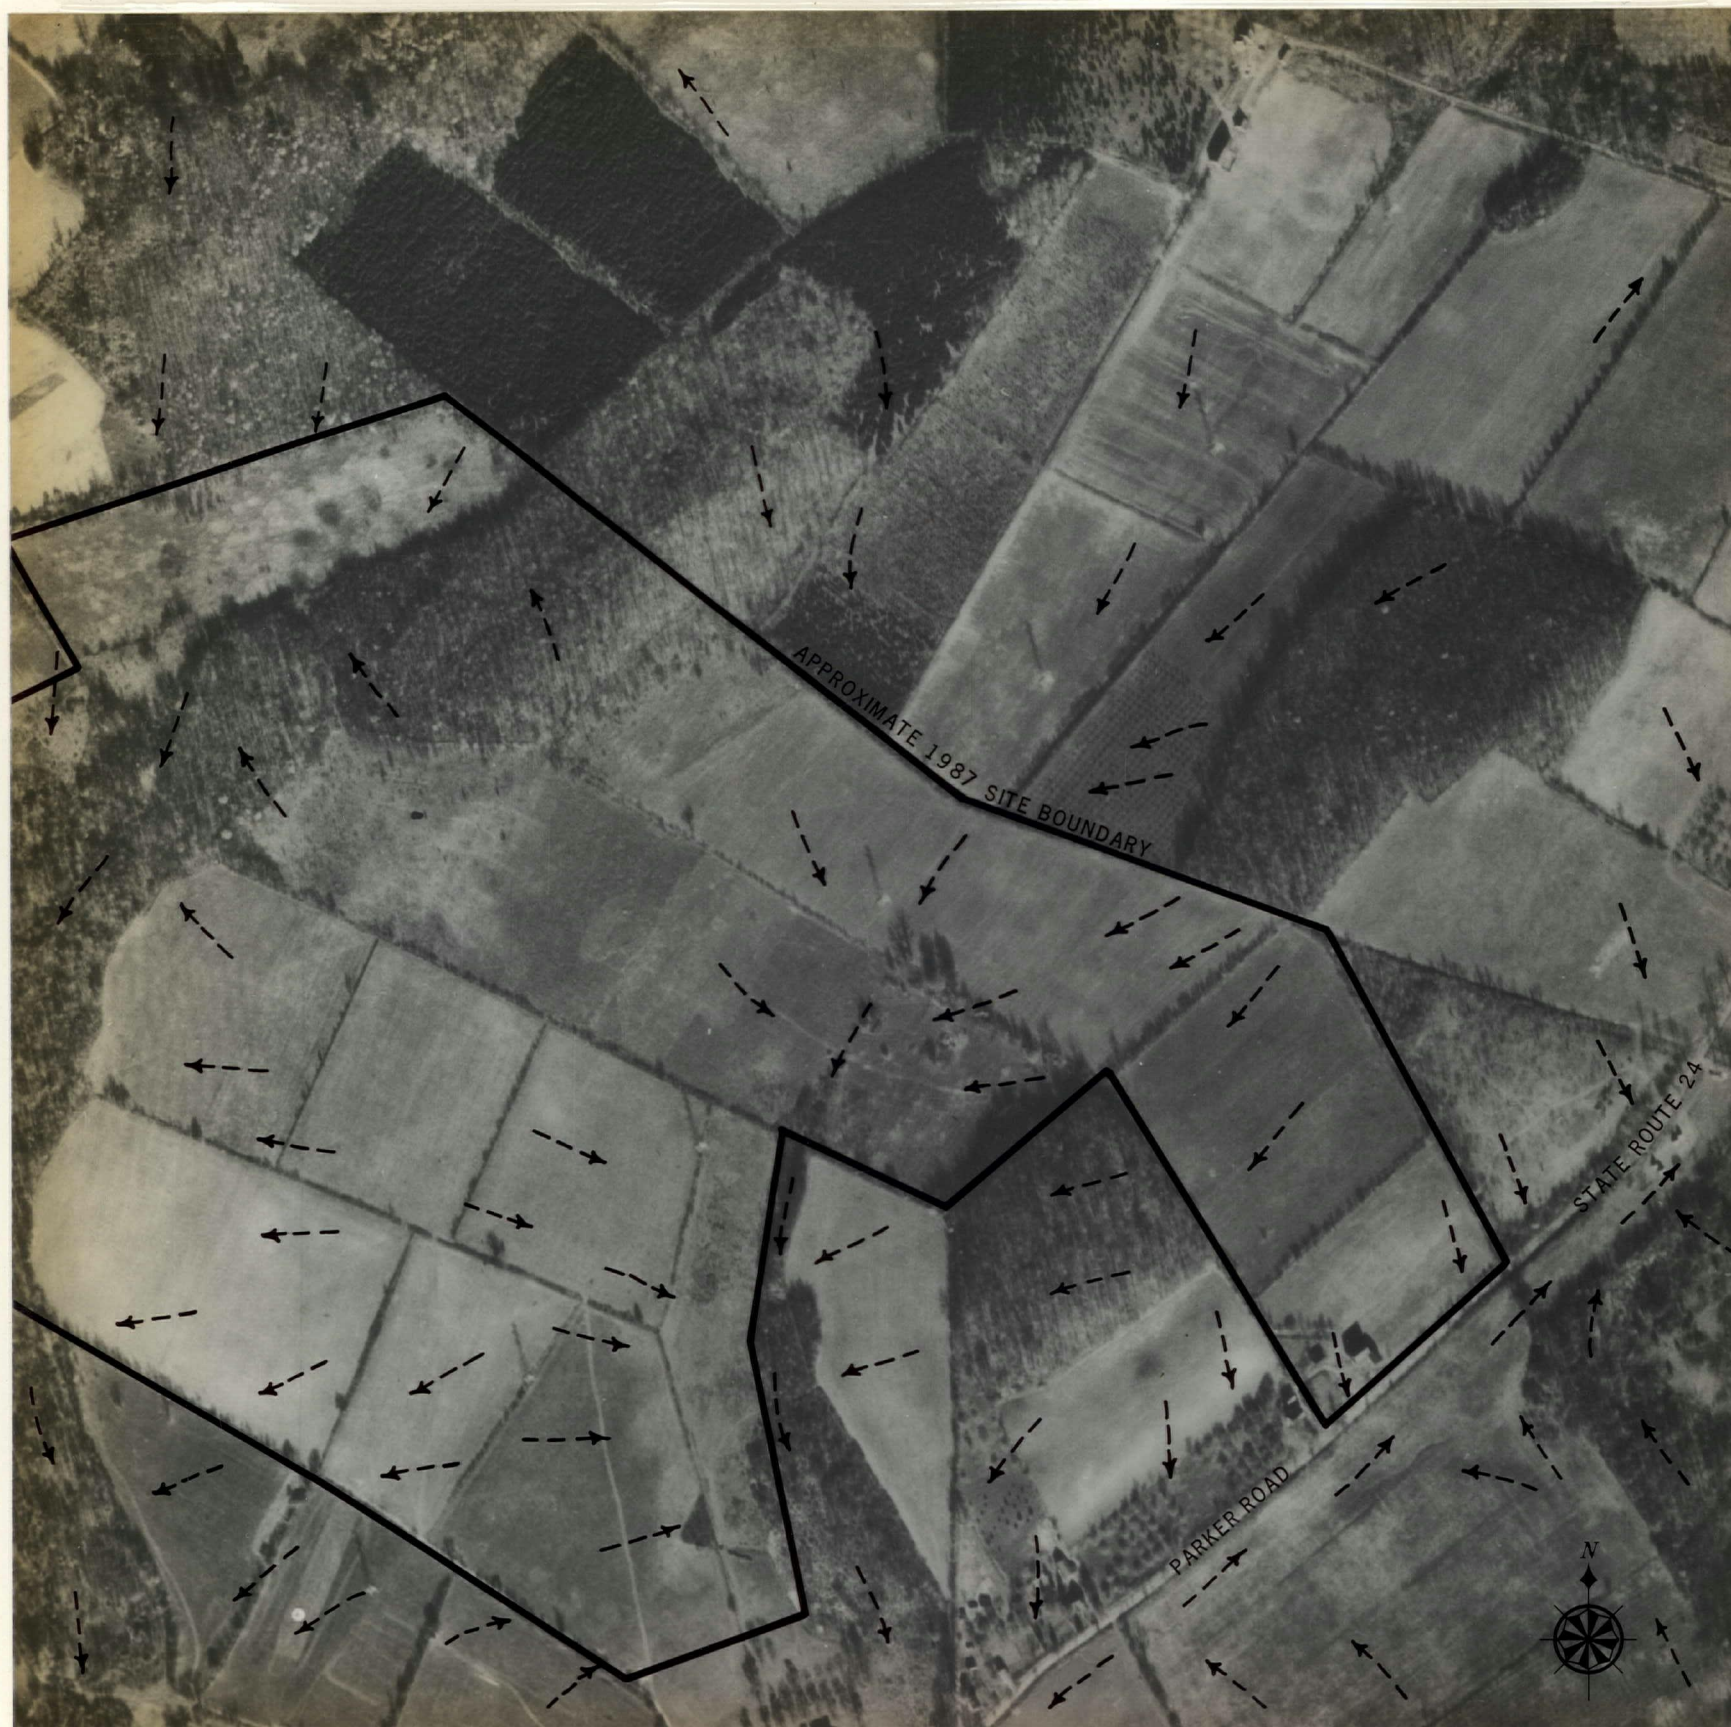
Figure 3. Combe Fill South Landfill, December 12, 1939. Approximate scale 1:5,175.

The Combe Fill South Landfill is not yet operational. The area which the site will occupy is outlined on the photo and consists of gently rolling terrain occupied predominantly by farm tracts and open pasture. The areal drainage is omnidirectional off the rolling hills with an overall tendency to the southwest. A few farmsteads are located along Parker Road (State Route 24).

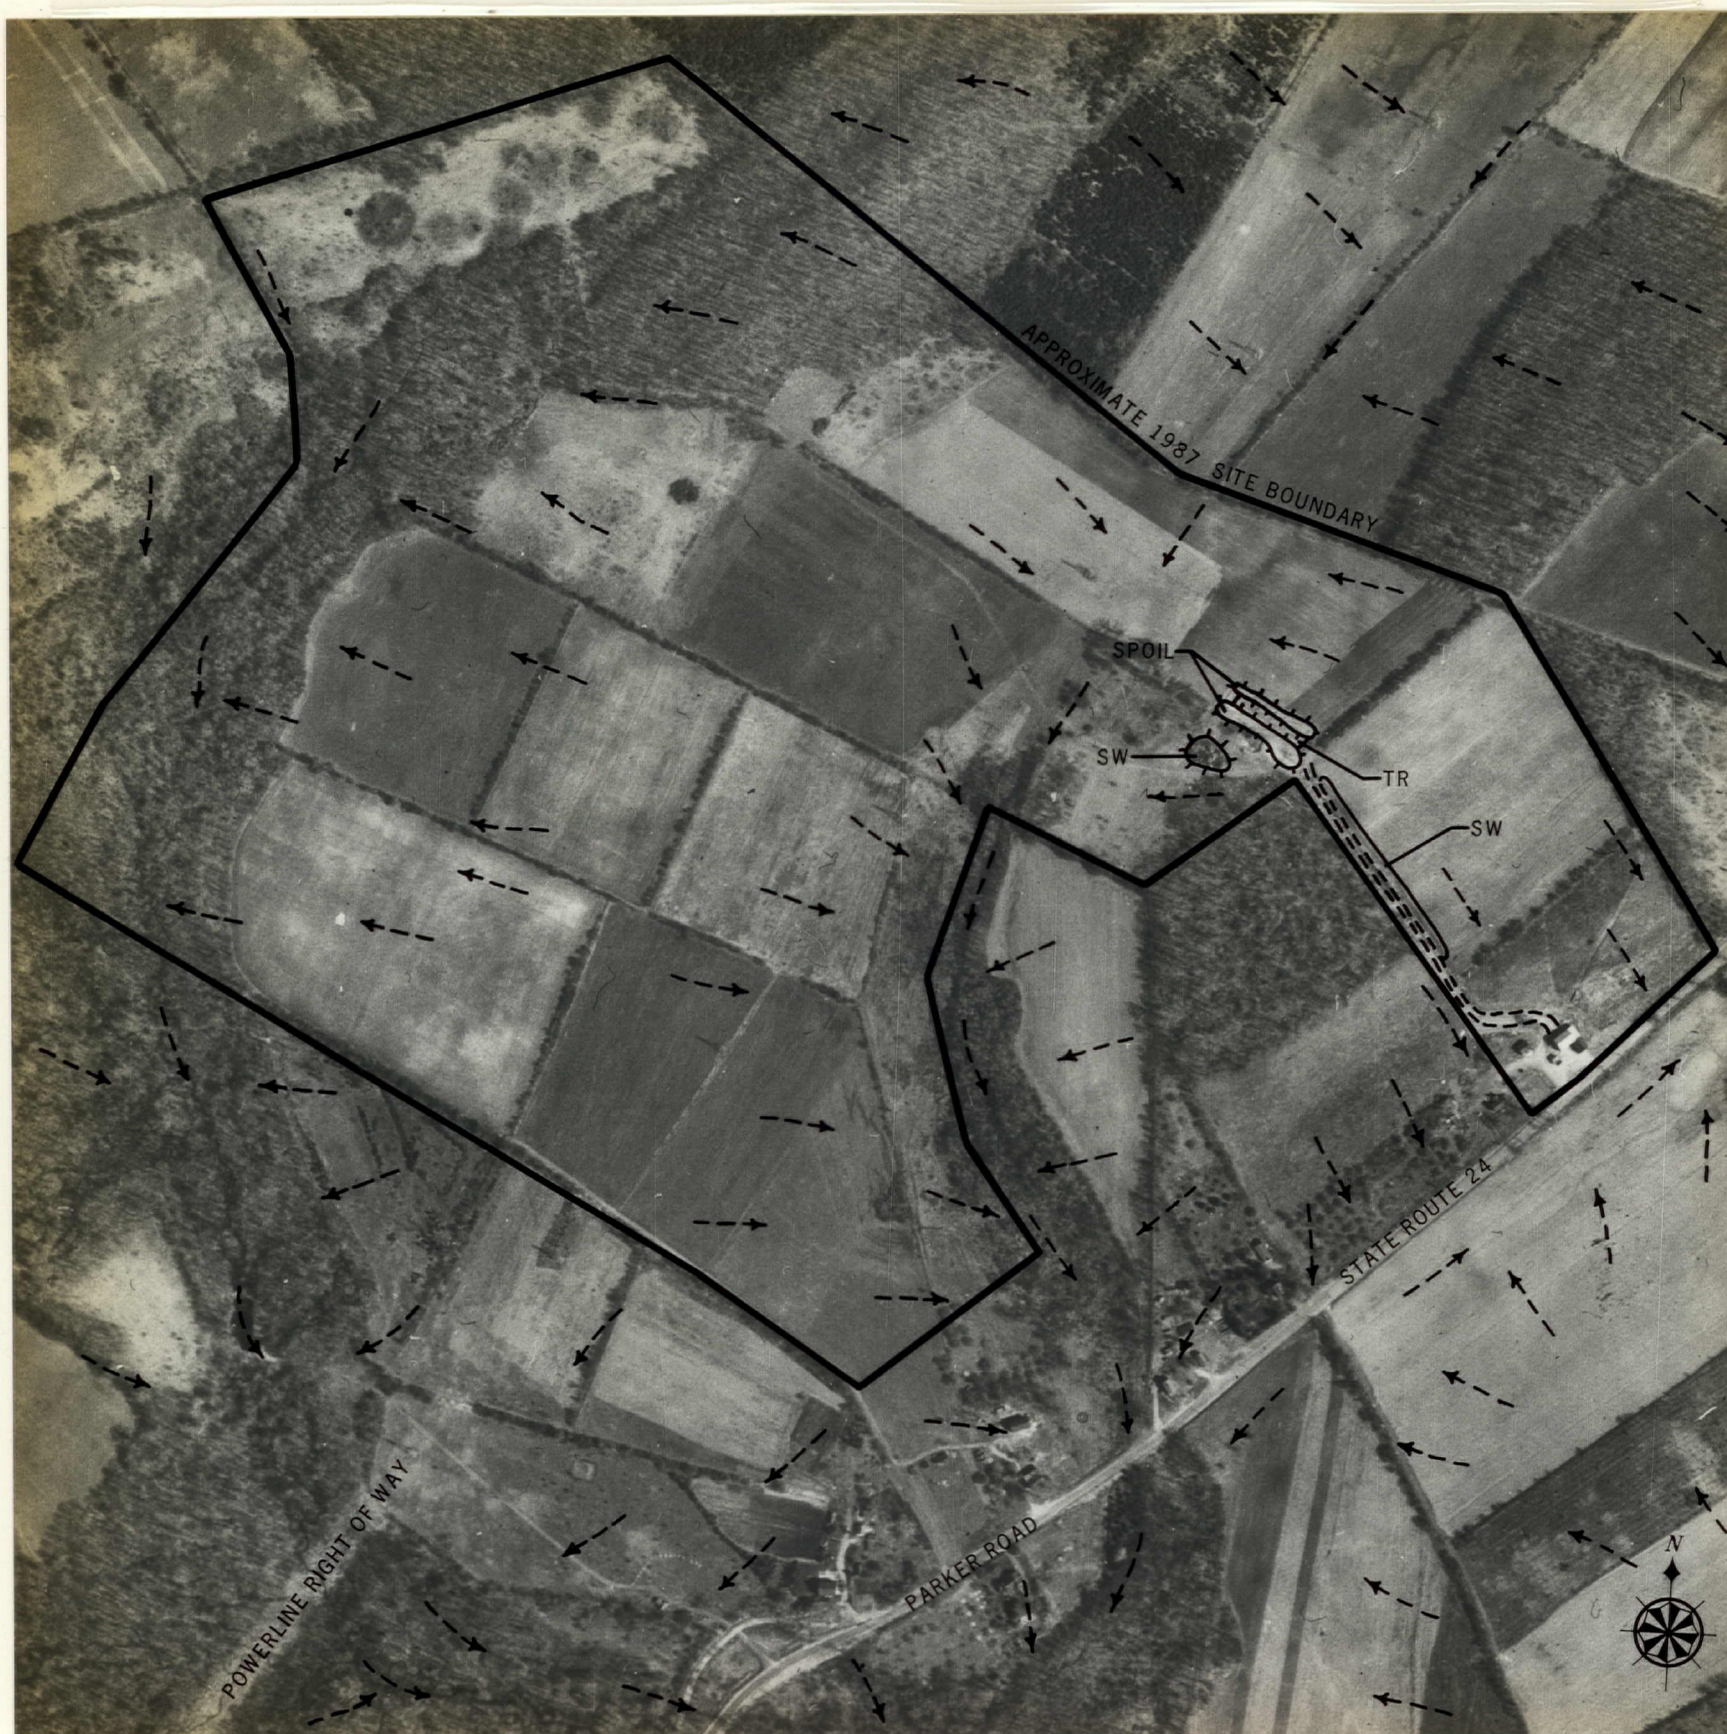
Figure 4. Combe Fill South Landfill, April 24, 1951. Approximate scale 1:5,950.

This photo shows that waste disposal activities are possibly taking place at the Combe Fill South Landfill. A small trench, measuring approximately 35 feet by 210 feet, is visible within the site perimeter. Spoil piles are noted along both sides of the trench. A small pile of unidentified solid waste is located adjacent to the trench. Solid waste/trash is also noted along the dirt access road to the trench. The remainder of the area within the site remains relatively unchanged since the 1939 photo (Figure 3).

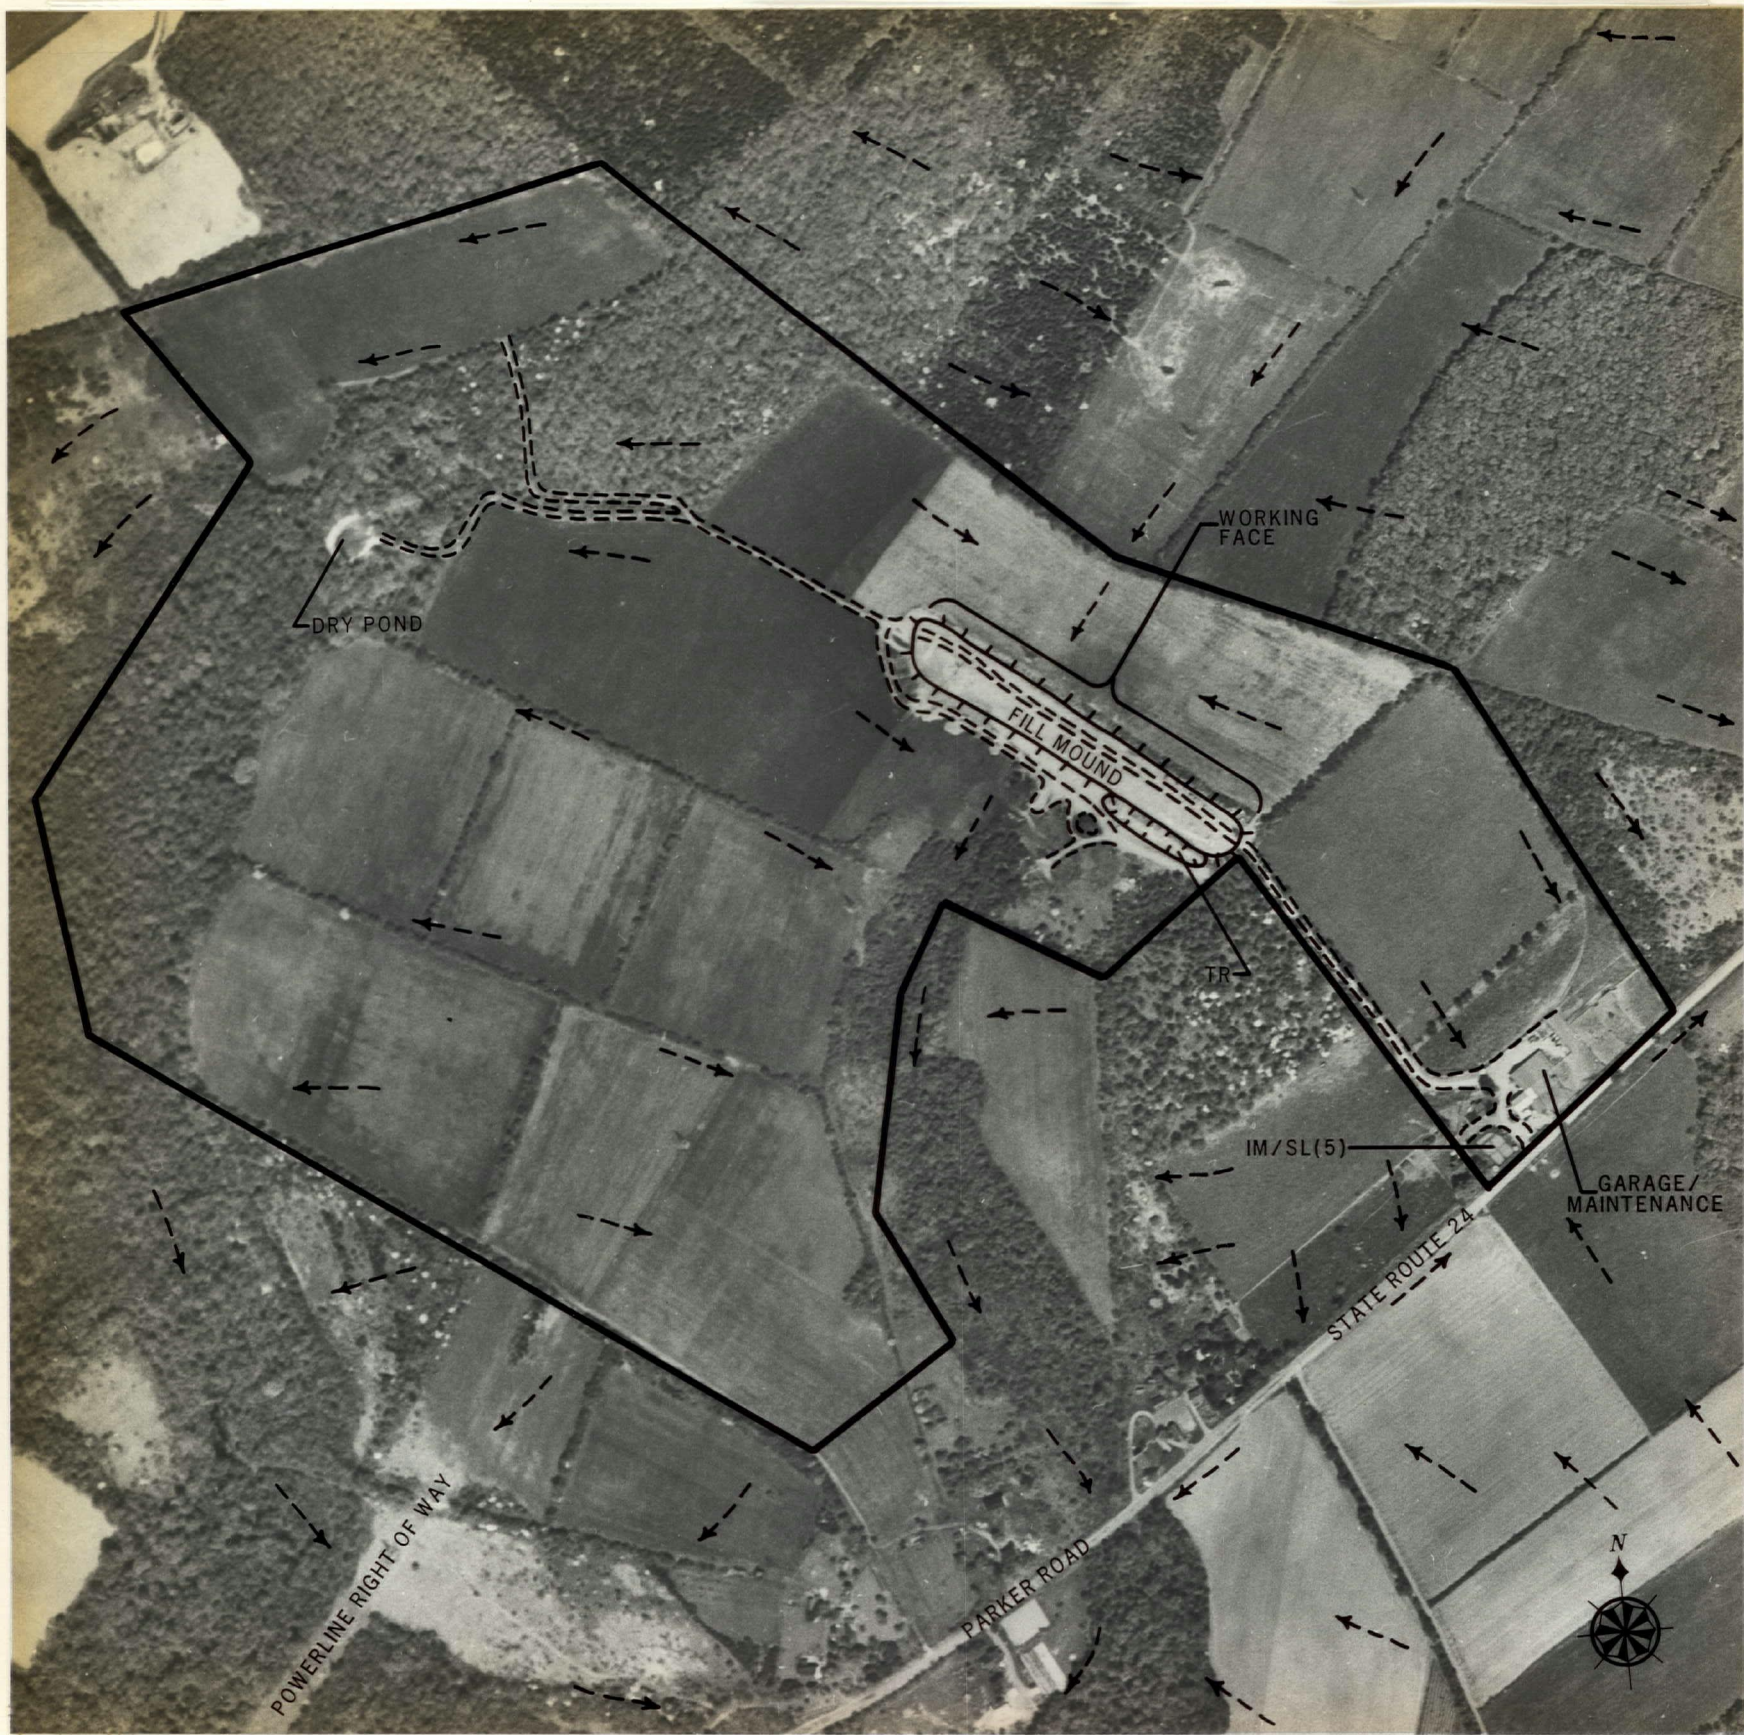
Figure 5. Combe Fill South Landfill, May 7, 1957. Approximate scale 1:5,550.

Waste disposal activities at the Combe Fill South Landfill have increased since the 1951 photo coverage (Figure 4). An active waste disposal mound, measuring approximately 110 feet by 900 feet, is now visible. This mound covers the small trench noted in 1951. The northeast side of the mound is the working face. A small, unlined trench is noted on the southwest side of the fill mound. This trench measures approximately 50 feet by 290 feet and at the present time is empty. Five small, unlined impoundments, containing a light-toned liquid, are visible near the main entrance to the site. An earthen embankment surrounds these impoundments. A garage/maintenance building has also been added in this area. A dirt road extends from the fill mound to the northern portion of the site. One branch of the road terminates at an empty field, while the western branch extends to a dry pond. No dumping activity is currently visible in these areas, though the road's presence may be indicative of future activities.

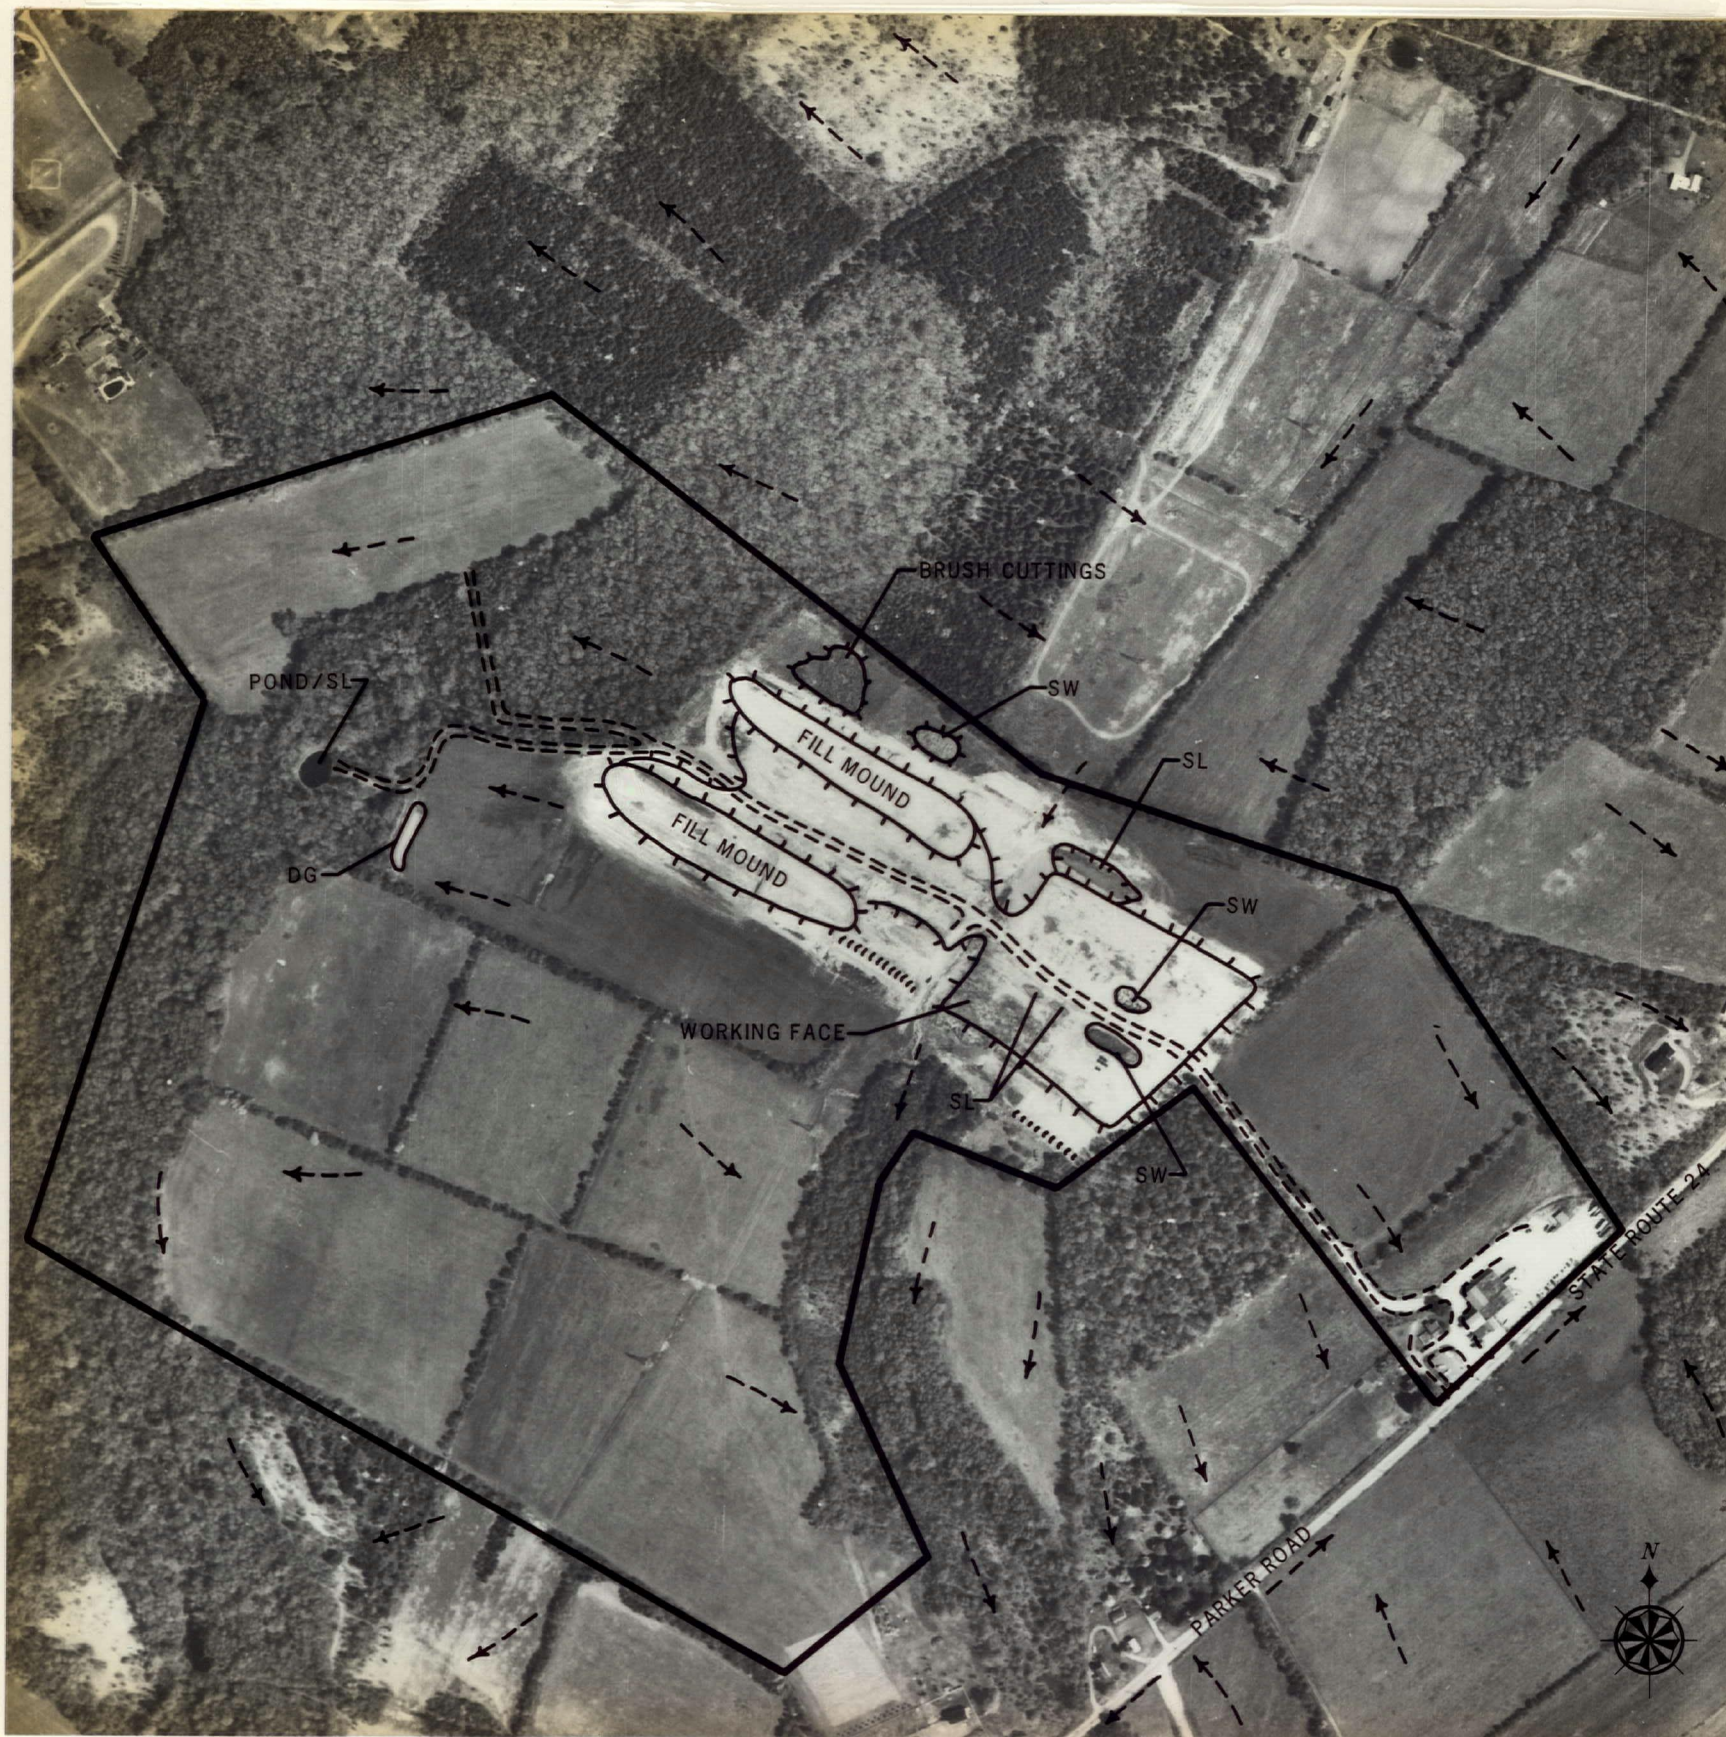
Figure 6. Combe Fill South Landfill, May 7, 1963. Approximate scale 1:5,175.

Waste disposal activity at the Combe Fill South Landfill has increased significantly since the 1957 photo coverage (Figure 5). The site appears to be an area fill layer operation. The southeastern fill mound measures approximately 420 feet by 510 feet. The northwestern fill mound is irregularly shaped and measures approximately 390 feet by 660 feet. Two fill mounds have been added atop the original layer of the northwest mound. These two mounds are approximately the same size, measuring approximately 125 feet by 610 feet. Two piles of solid waste are noted atop the southeastern fill mound. The working face of the site is located centrally along the southwestern slope. Another pile of solid waste and a pile of what appears to be cut brush are noted just east of the new fill mounds. No activity is noted at the end of the dirt road northwest of the fill area, though liquid is noted in the previously dry pond. An area of disturbed ground is also noted off the dirt road, near the pond. The five impoundments, located near the main entrance on the 1957 photo, have been removed and the area is now being used for vehicle parking.

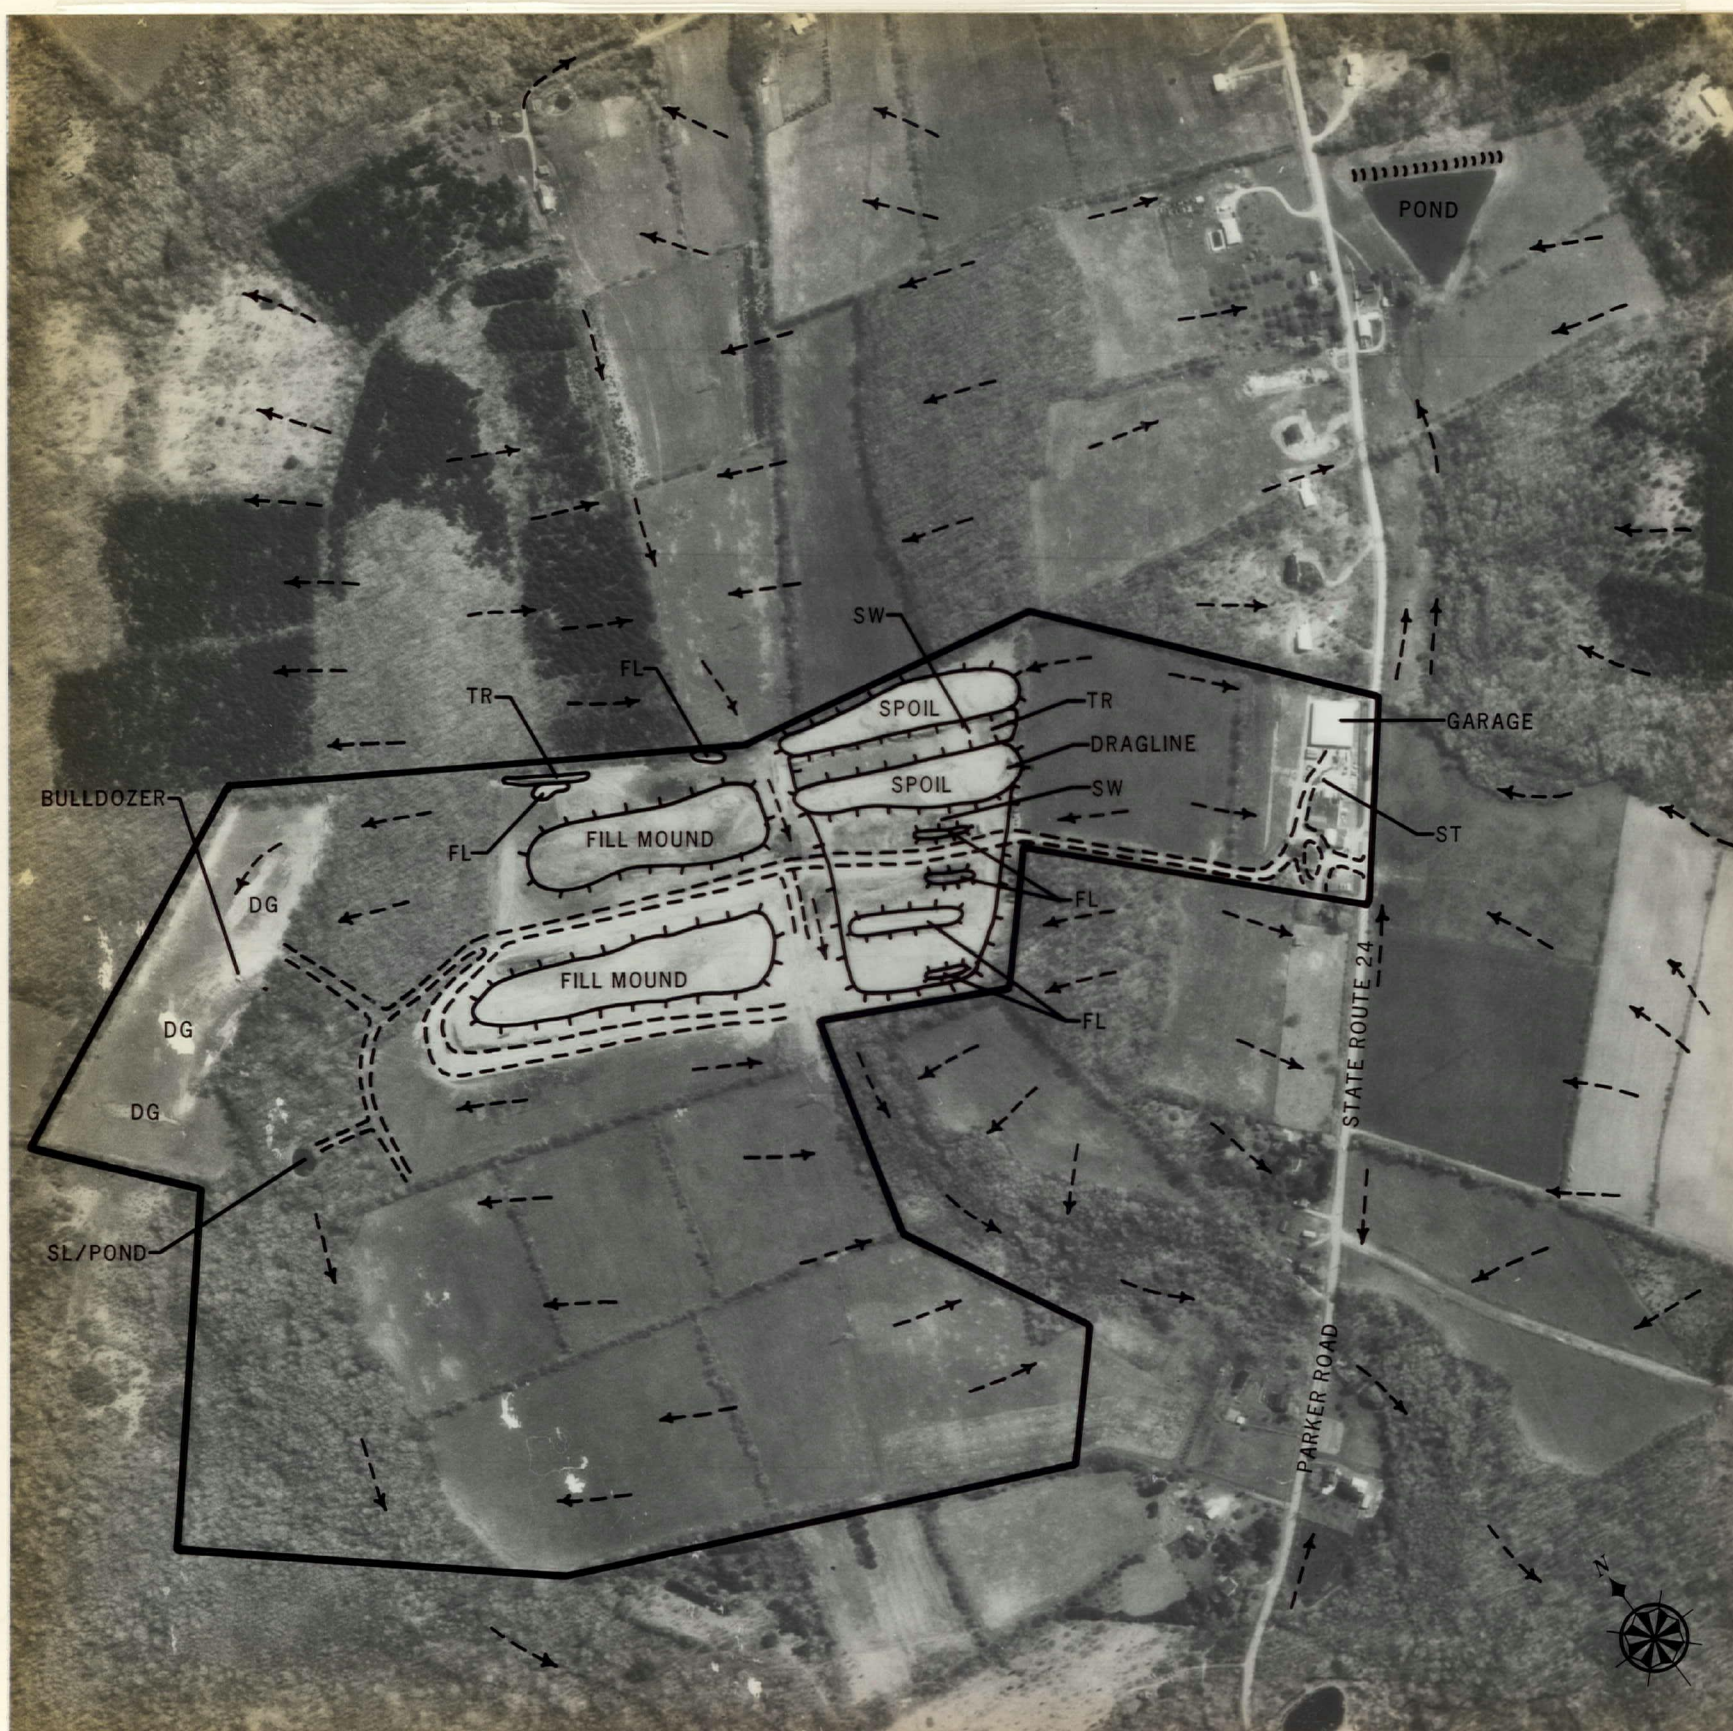
Figure 7. Combe Fill South Landfill, May 11, 1966. Approximate scale 1:5,950.

Little change is noted to the two northwestern fill mounds at the Combe Fill South Landfill since the 1963 photo coverage (Figure 6). A large trench has been excavated in the eastern half of the southeastern fill mound. Two large spoil piles, excavated from the trench, are noted on either side. A dragline is visible near the southern end of the trench. Solid waste is visible on the floor of the trench, which measures approximately 135 feet by 575 feet. Four small fill piles are noted west of the spoil piles. Disturbed ground, in an open field at the end of the dirt road north of the fill, is caused by bulldozer activity. The linear shape of some of the ground scarring may indicate burial activity in trenches. A bulldozer is noted active in the area. The disturbed ground, previously noted near the pond in 1963, is no longer visible. A new garage/maintenance building is noted in the entrance area to the site. An oil stain, probably due to vehicular traffic, is noted near the garage.

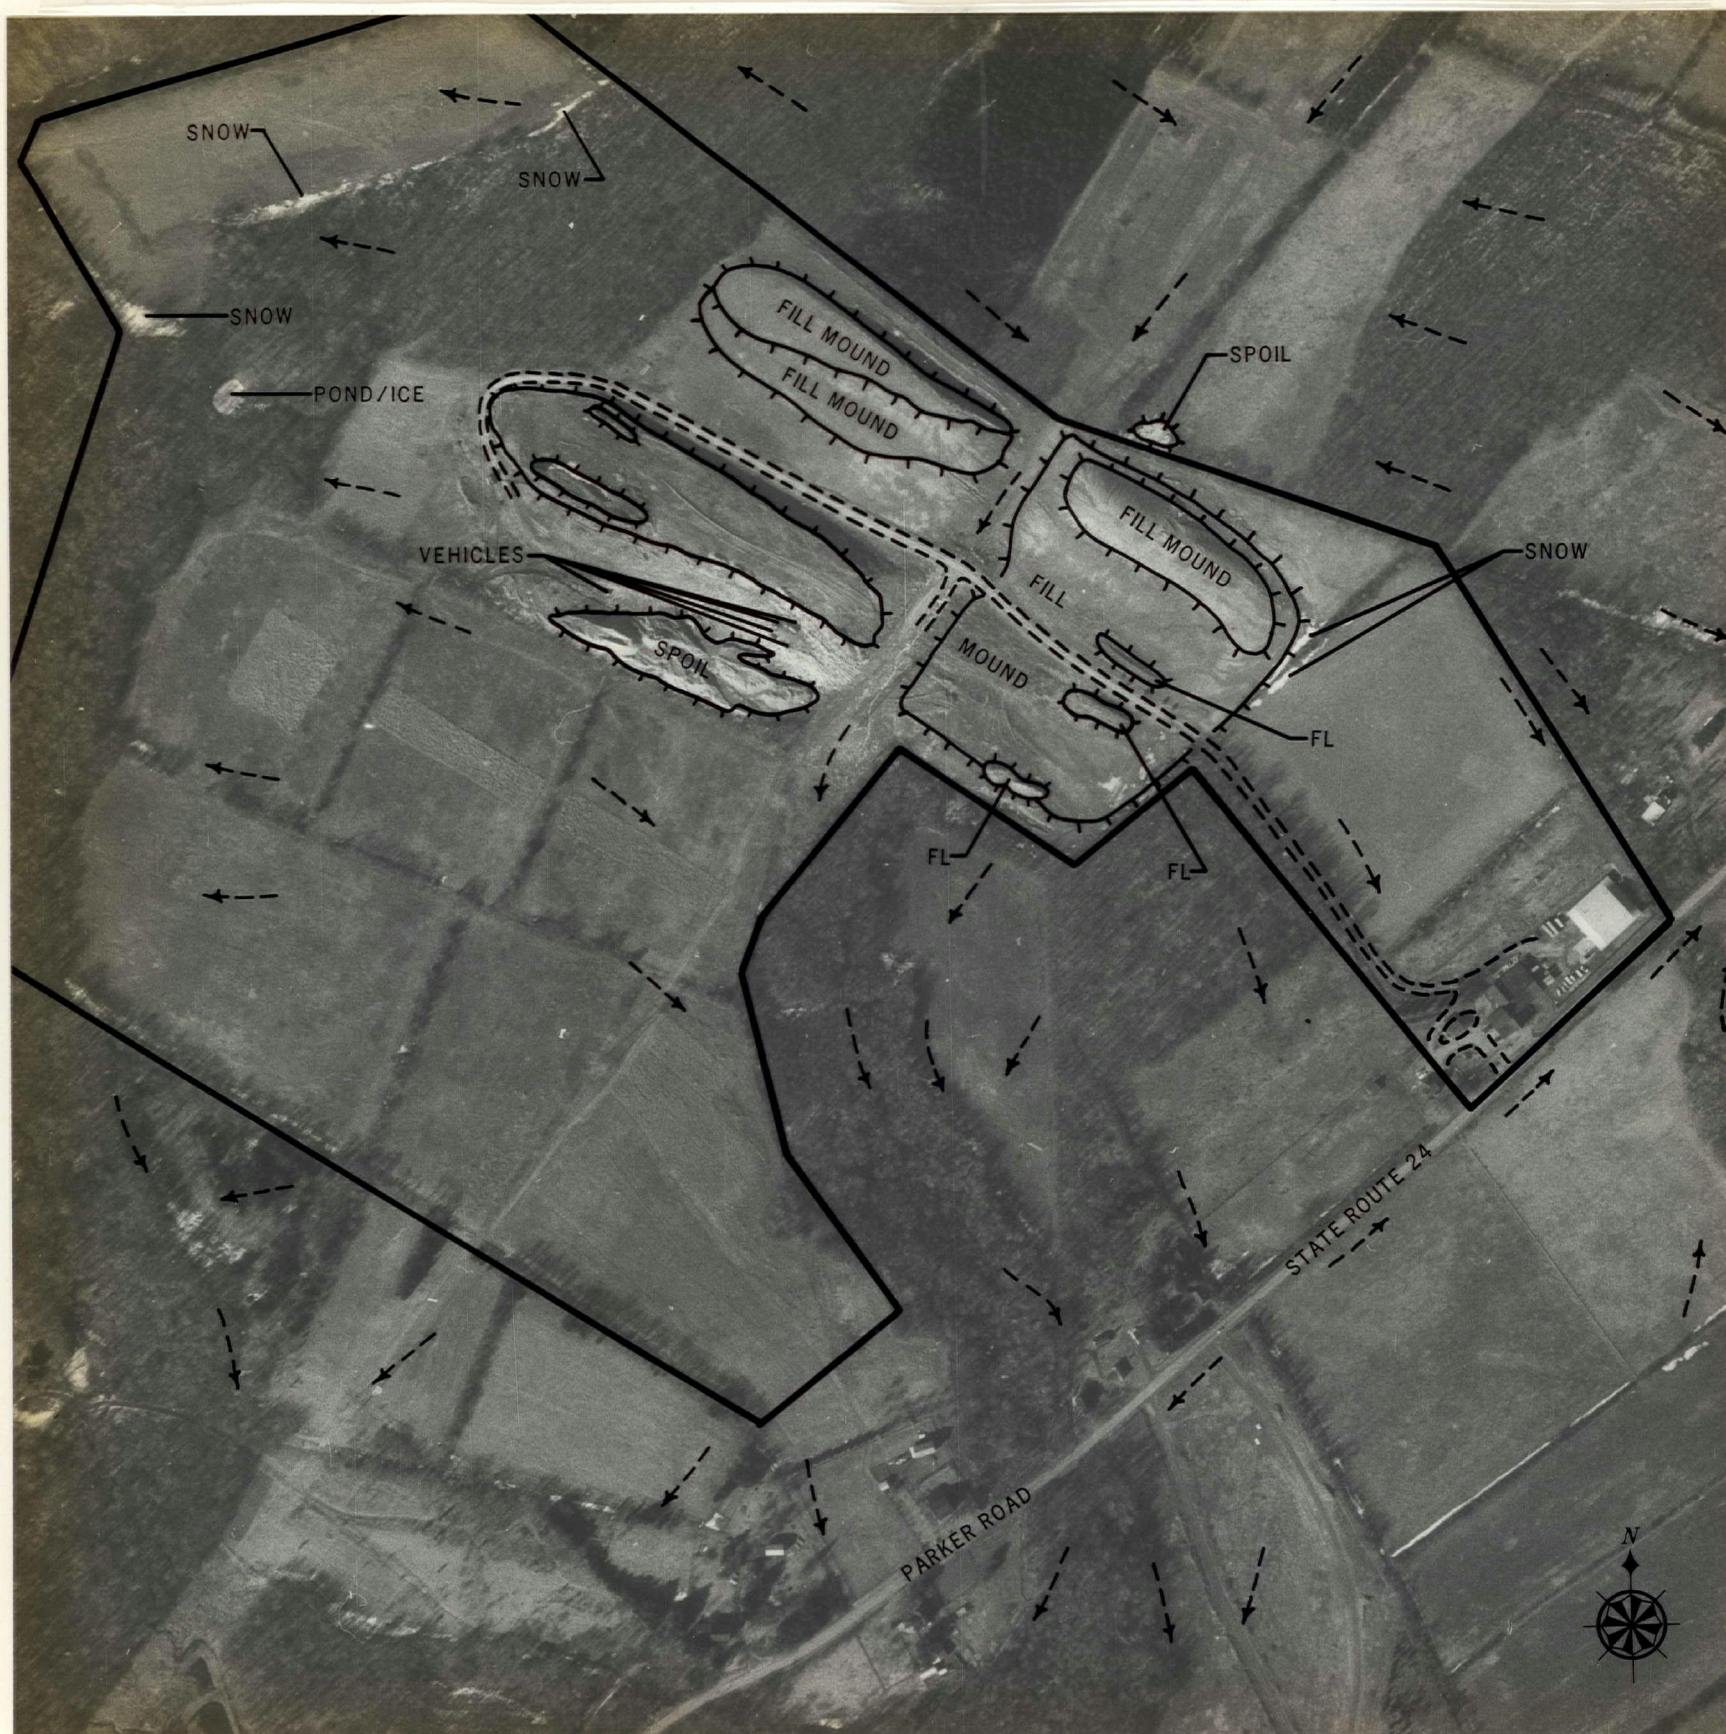
Figure 8. Combe Fill South Landfill, February 24, 1970. Approximate scale 1:5,175.

Little change is noted at the Combe Fill South Landfill on this date. The fill mounds all appear weathered indicating a long period of inactivity. The large trench noted on the 1966 photo coverage (Figure 7) has been filled and covered. A new fill mound now covers this trench. Some excavating activity is noted on the northwestern mound. There are no visual indications of solid waste dumping on this date. The landfill appears to be well maintained.

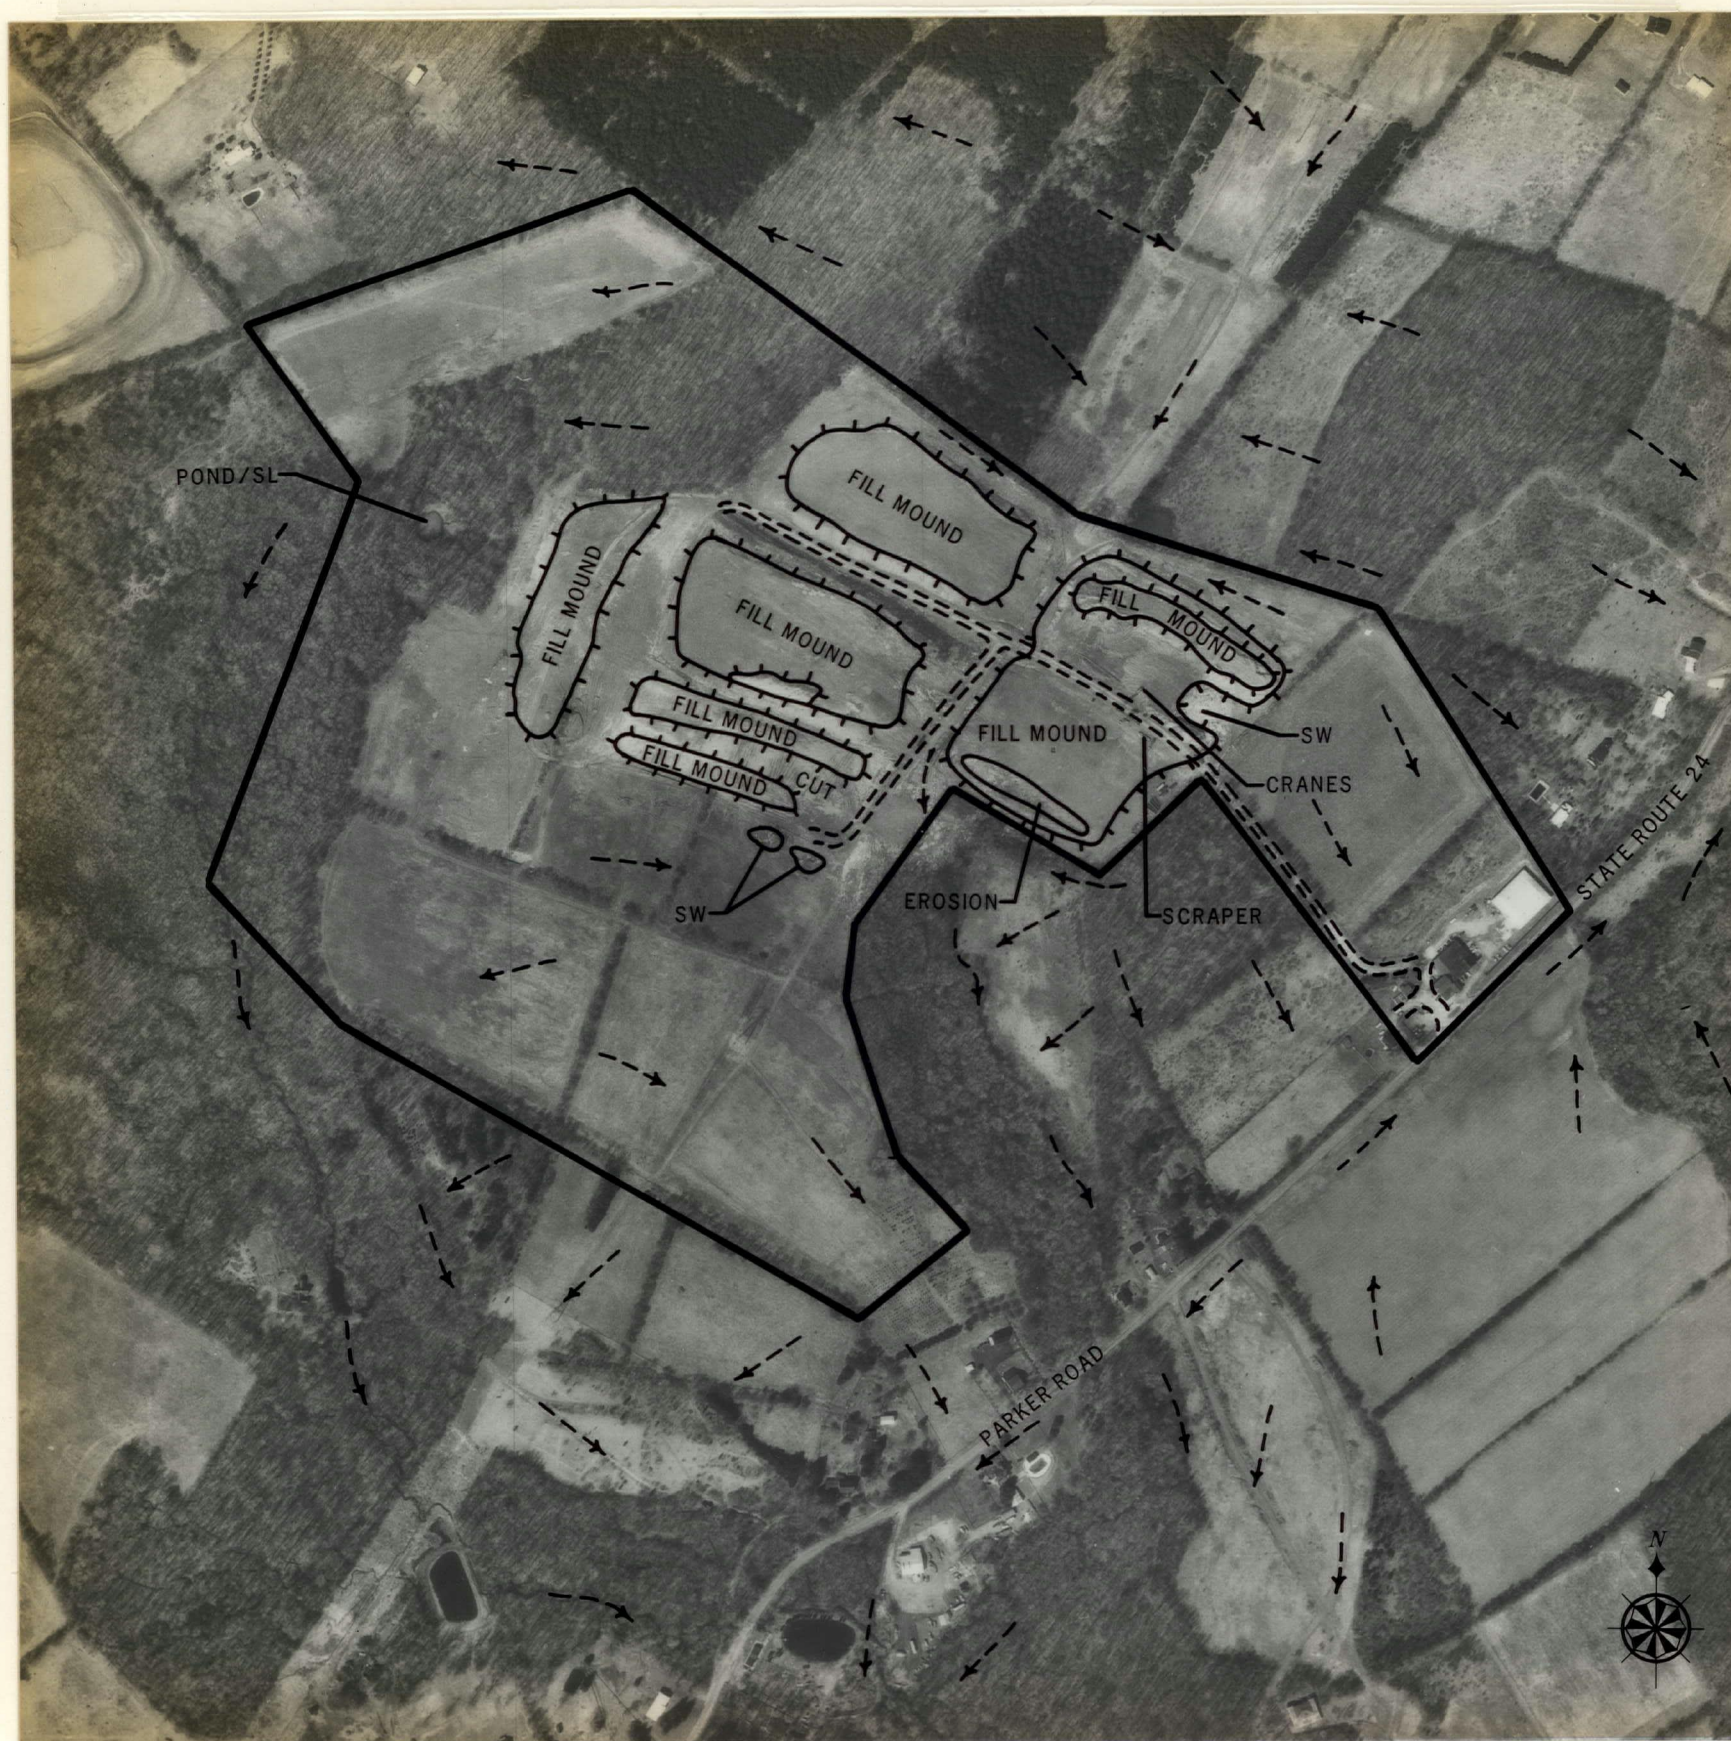
Figure 9. Combe Fill South Landfill, April 3, 1974. Approximate scale 1:5,950.

Dumping activity continues at the Combe Fill South Landfill. The fill mounds have increased in size. A new cut has been made in the southeast mound and trash is being dumped in this area. Two cranes and a scraper are noted in the area. Some erosion is visible along the west side of this fill mound. The mottled appearance could indicate buried waste is surfacing in the area. It appears that the landfill is expanding further to the southwest. An additional fill mound and two small piles of trash are noted in this area.
